## Bag Liner's in waste bins under negative pressure dust extractors

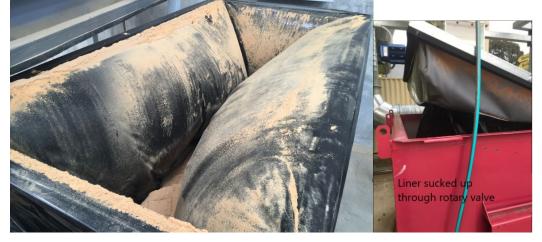
The liner comes away from bin wall and continues to rise up into the filters taking dust with it and stoping the filters from breathing, this can happen on Wheelie bins also

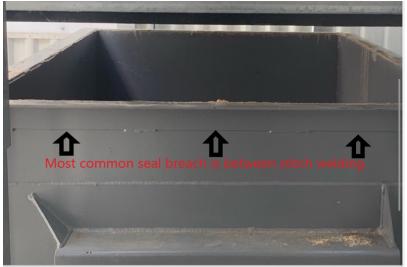
Most common place that the seal is broken is on the top lid of the waste bin between the stich welds. Easily fixed with all weather sealant (roofing silicone etc)

Drain plug if not sealed properly also causes liner rising, a bung should be fitted with a sealant
